# A Rema Remode

Turning a quirky rustic lodge into a comfortable modern home is a problem-solving proposition

**BY BRIAN PONTOLILO**

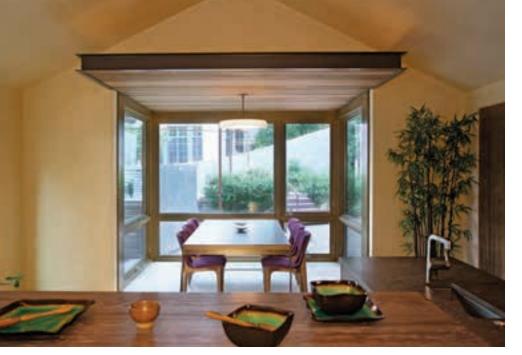
#### **RADIANT TEXTURE**

The existing stone chimney, with it's Viking head and unfinished Nordic epitaph, was converted to a gas fireplace. The interior design is a balance of rustic texture and clean lines—the former created with details like the herringbone-pattern flooring, wire-brushed cabinetry, and glass-tile backsplash; the latter achieved with modern details like the drywall returns in place of window and door casings, the flat-panel cabinetry style, and the steel-framed dining-room ceiling.

stone fireplace, it has modern elements too. For example, the white-oak flooring is set in a herringbone pattern and the white-oak cabinetry has a wire-brush finish, both chosen to carry the rich texture of the fireplace around the interior. The steel handrail in the entry, the steel-framed dining-room ceiling, and the plaster returns at the windows and doors give the house clean, modern lines.

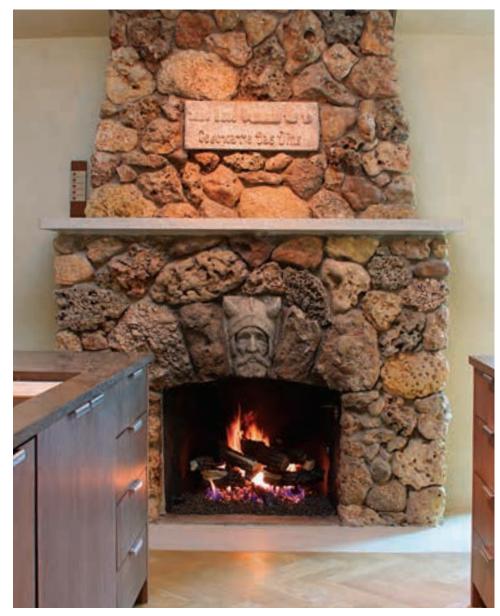
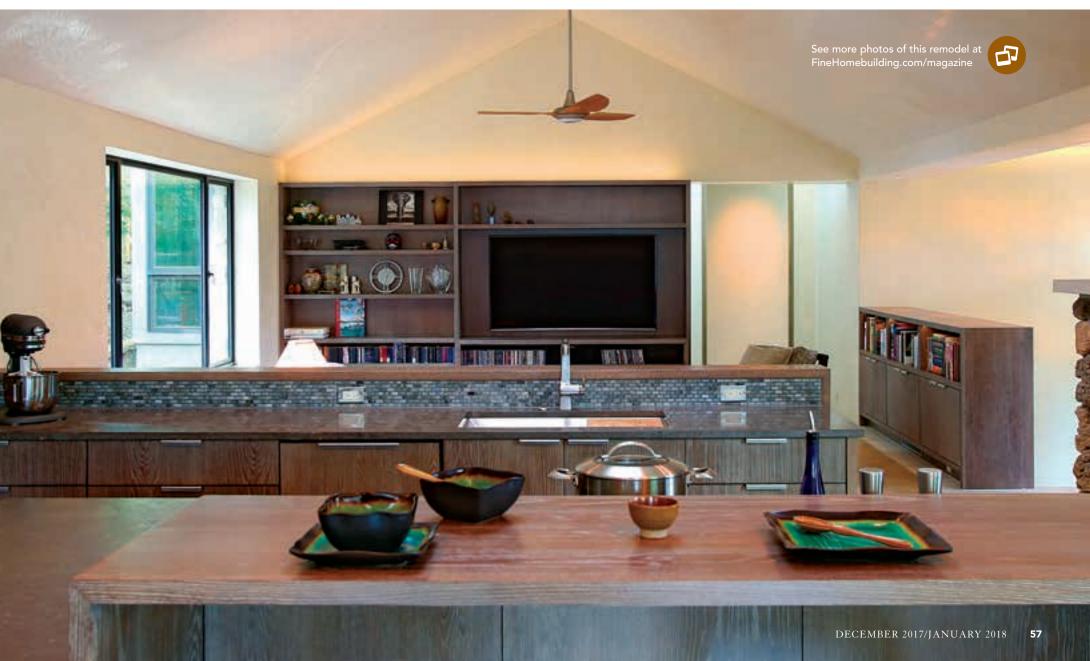
### **MONOLITHIC MASONRY**

The home's original walls, built with stone likely collected nearby, extend below grade to act as their own foundation. The owner wanted to keep as much of the walls intact as possible to retain the old-fishing-lodge charm. In the end, however, much of the walls would need to be rebuilt to repair a number of conditions and correct their odd original construction.

No one is quite sure when the lodge was built or who built it. The stone is believed to have been collected from the river and the masonry work was likely part of an amateur, owner-built project. The original stone walls, which extend below grade to act as the foundation, varied in thickness from one to the next. And the gables were not even close to square. Though some of each original gable wall stayed intact, much of what looks original was rebuilt to repair a range of problematic conditions.

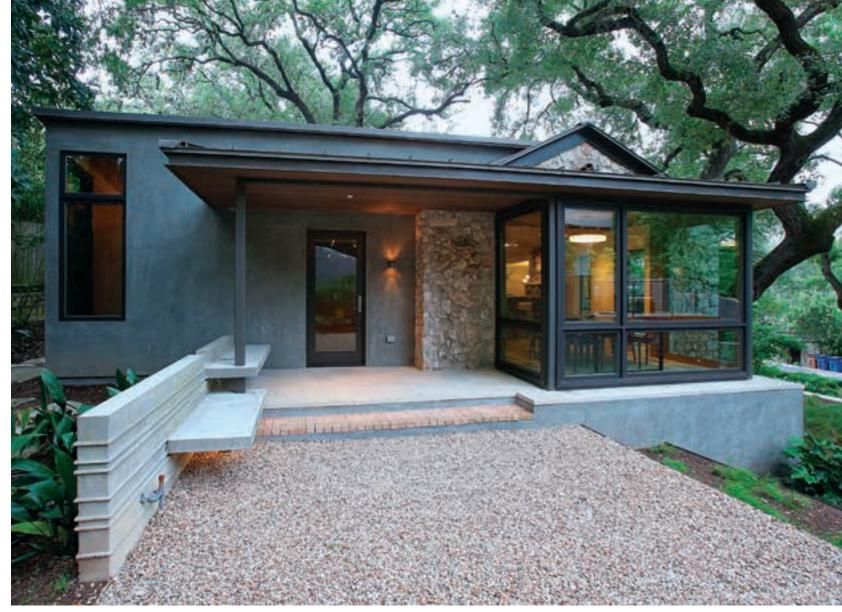
#### **DEMOLITION DERBY**

Though most of the original lodge was demolished, the remodeled house maintains a similar footprint that meets zoning setback regulations and protects the site's Heritage live oak trees. The bedroom addition is angled to the rest of the home to squeeze in a little extra space—the new home is about 100 sq. ft. larger than before the remodel. The landscape plan includes similarly patterned concrete and steel retaining walls used to terrace the grade. The garage siding detail mimics the retaining walls.

walls standing tall while the crew shores them up with shotcrete—sprayed concrete commonly used for pools-and pours new slab foundations for the additions. The lodge proper is built above a sealed crawlspace. The floors are framed like a deck, with ledgers hung on the masonry walls, now flattened by the shotcrete. The team decided to lower the height of the new slab foundations of the additions and frame the floors with sleepers so the finished floors have a similar feel to the wood-framed floors above the crawlspace.

Spraying the masonry walls with shotcrete also provided an opportunity to square the walls—inside the home, at least. Outside, the walls are still not square.
